# **Case Study**

## ANZAC Square Restoration, Brisbane, QLD

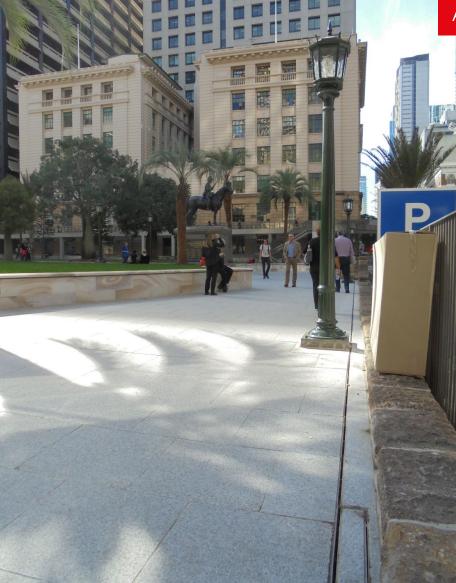
KlassikDrain K100 system with Brickslot top

- The 0.5% built-in fall slope of the KlassikDrain K100 channels allowed the pavements to be constructed flat and still provide sufficient runoff to the outlet within the system
- Brickslot's slotted top addressed pedestrian safety issues relating to stiletto heels
- The Brickslot system could be positioned close to the retaining walls ensuring a discreet drainage installation
